## **Islandmore Wind Farm**

Annex 14.1: Road Safety Audit

**Wind Farm Application, Toobrackan,  
Ballaghaderreen, Co. Roscommon  
Stage 1 Road Safety Audit**

| <b>Document No:</b> | 262305-ORS-XX-XX-RP-TR-13g-001 - RSA |

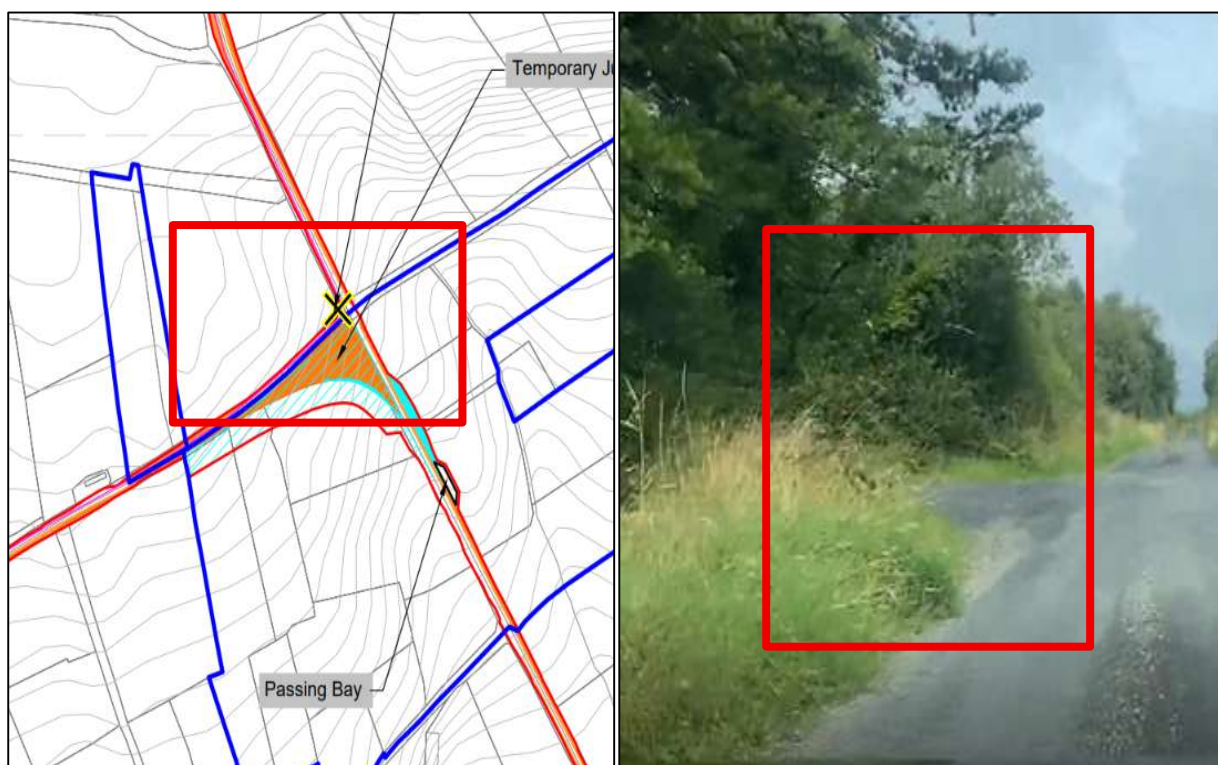
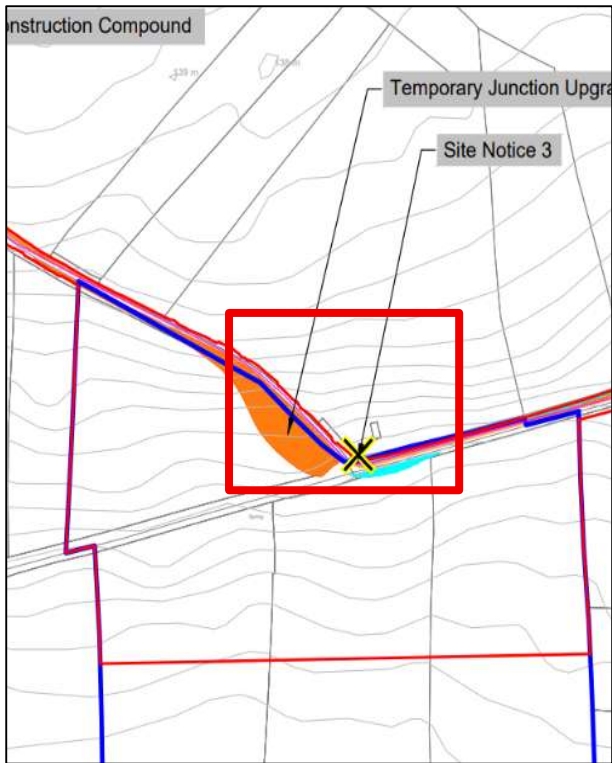
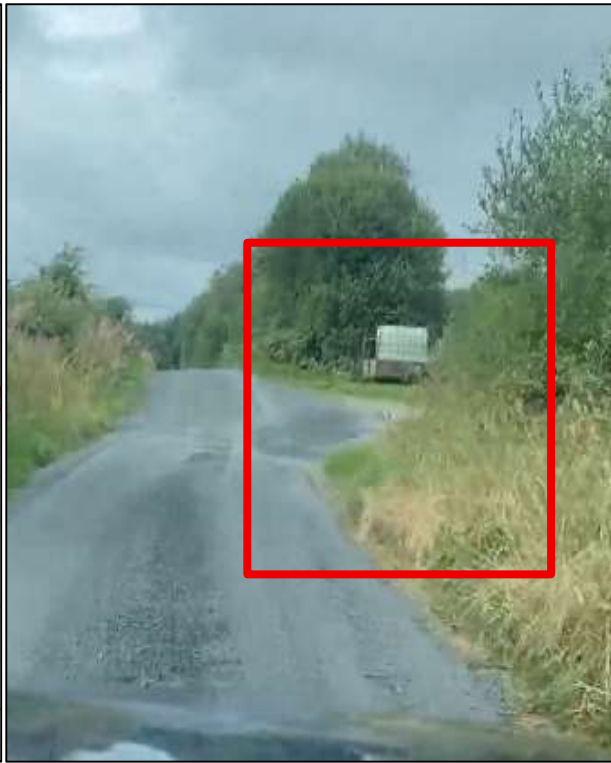
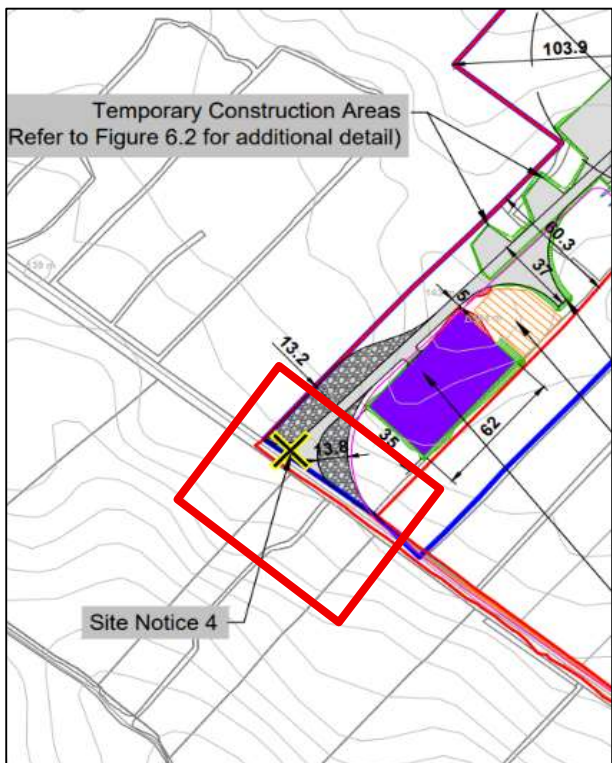
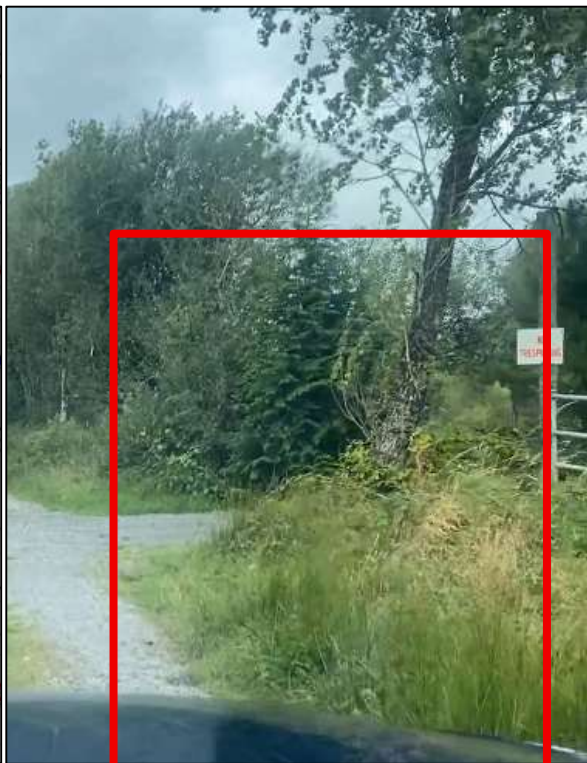
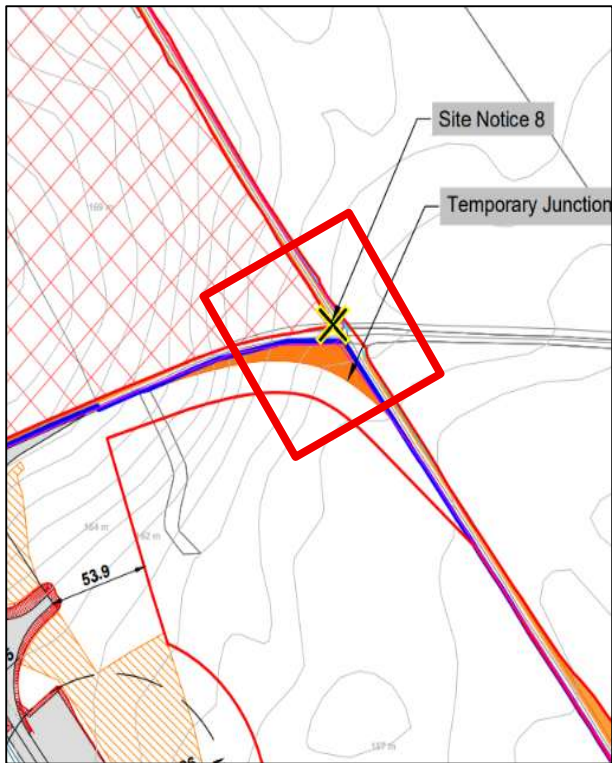
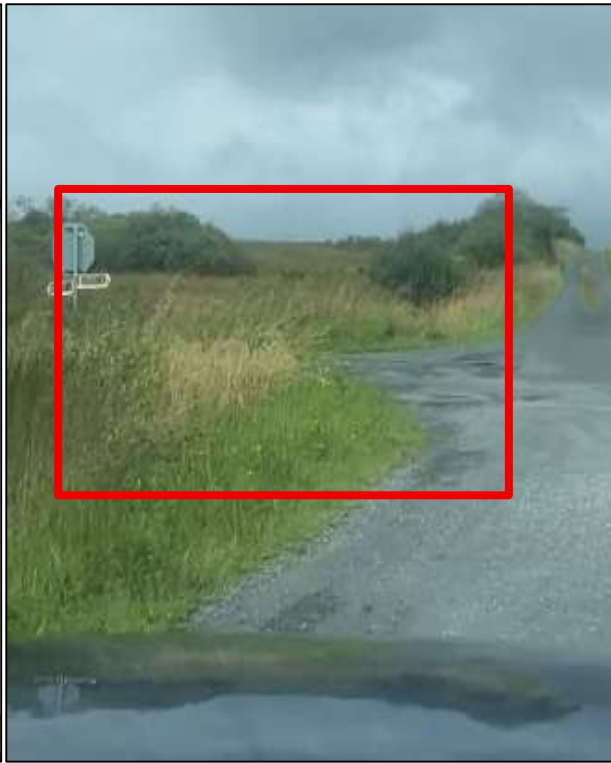
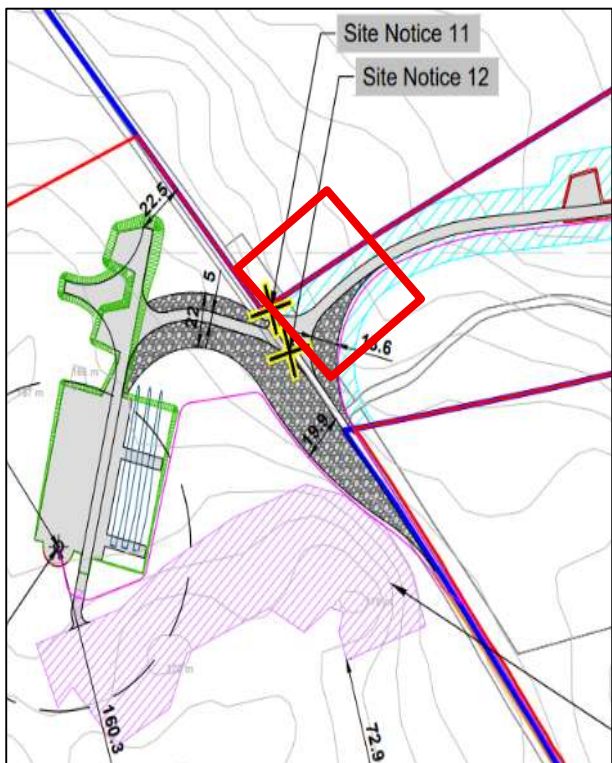
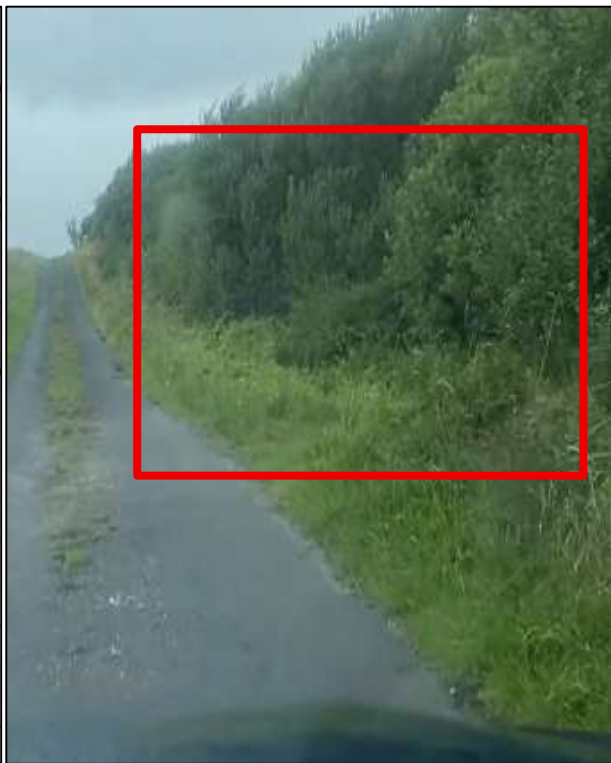
#### Problem No. 01: Sightline Visibility at Bends

The audit team note from the site visit that visibility is restricted at a number of bends along the access route due to existing vegetation, hedgerows and/or roadside features. The audit team are concerned that restricted sightlines from the junction and forward visibility may prevent drivers from identifying approaching vehicles in sufficient time to react safely, particularly given the anticipated HGV movements associated with the proposed development.

The design team should ensure that adequate visibility is maintained at the locations identified and that any obstructions are removed or appropriately managed.

| Problem Reference in Safety Audit Report | To Be Completed by the Designer | | | To be Completed Audit Team Leader |
|---|---|---|---|---|
| P01 | Yes | Yes. The site entrance and junction locations identified will be subject to permanent or temporary upgrade works which shall include improvements to visibility. | | |

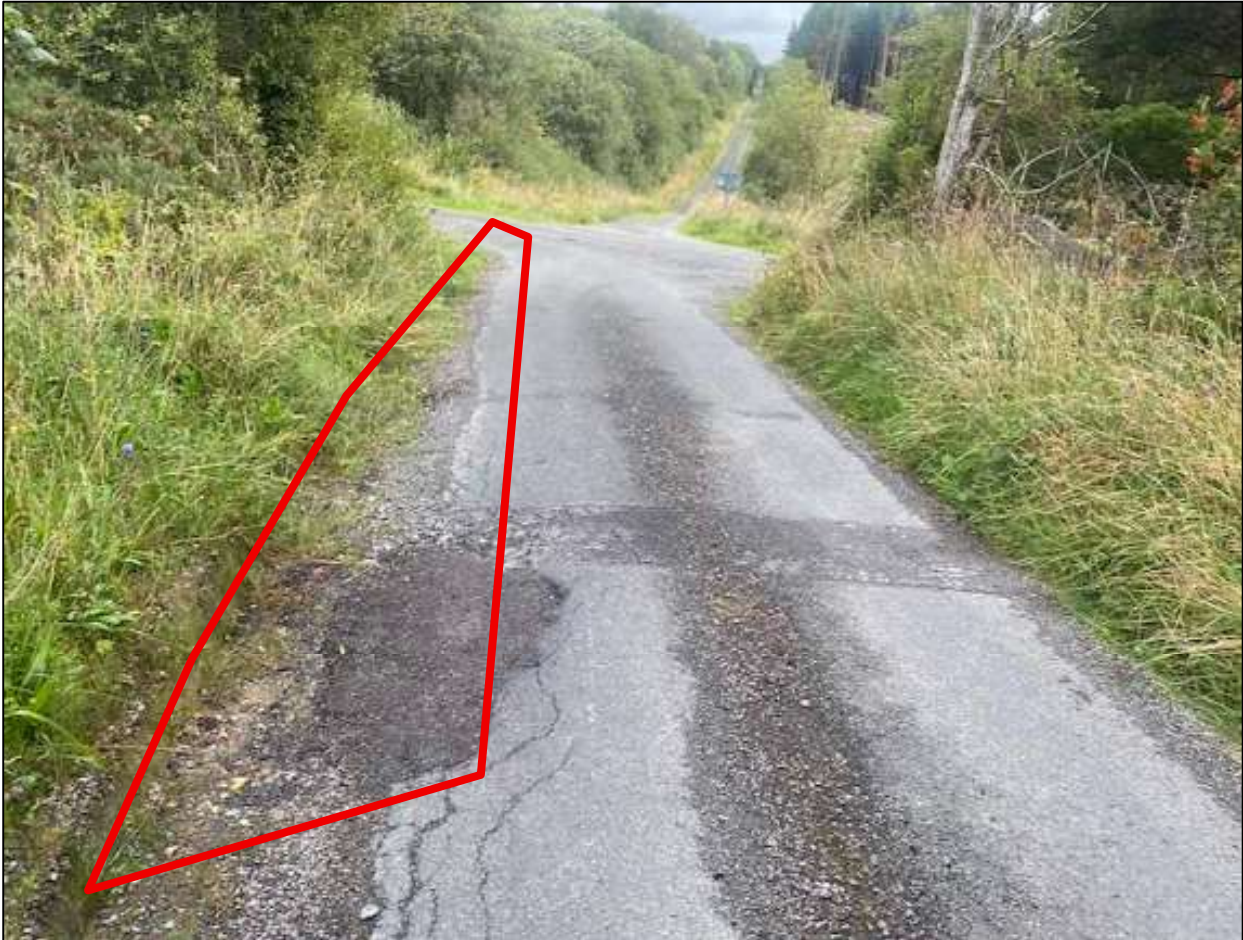
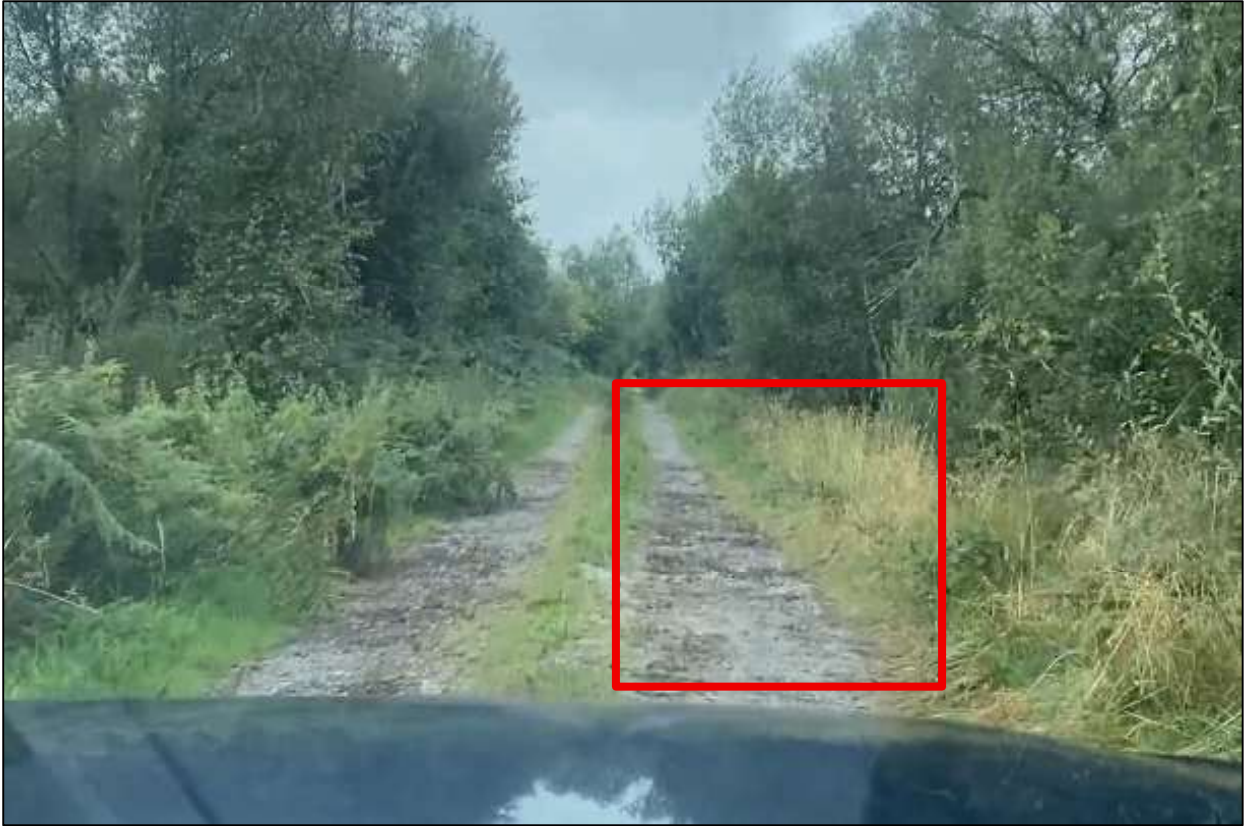
**Problem No. 02: Soft Verges Along Local Road on Approach Route**

The audit team note from the site visit that there are areas of soft/boggy roadside verge along the proposed access route. The audit team are concerned that HGV and abnormal load vehicles may be required to overrun these areas when negotiating the narrow sections of road. This may result in vehicle instability, damage to the road edge or loss of control, increasing the potential for collisions.

The design team should ensure that the appropriate verge markers, edge lining is introduced. These photos are examples and checks should not be confined to these areas only.

| Problem Reference in Safety Audit Report | To Be Completed by the Designer | | | To be Completed Audit Team Leader |
|---|---|---|---|---|
| P02 | Yes | Yes. The proposed development provides for the widening of the carriageways of local roads as required. Verge markers and edge lining will be provided at required locations. | | |

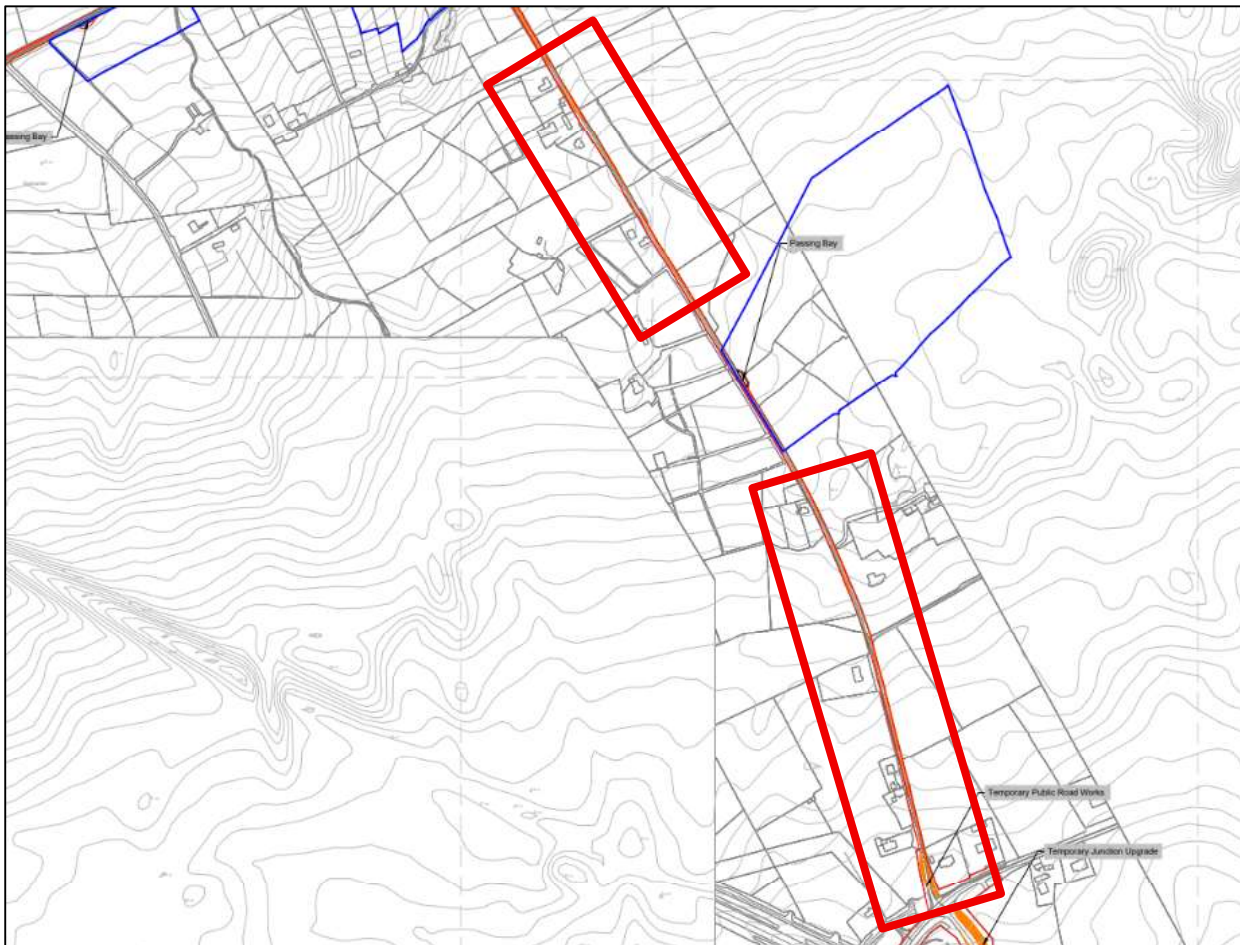
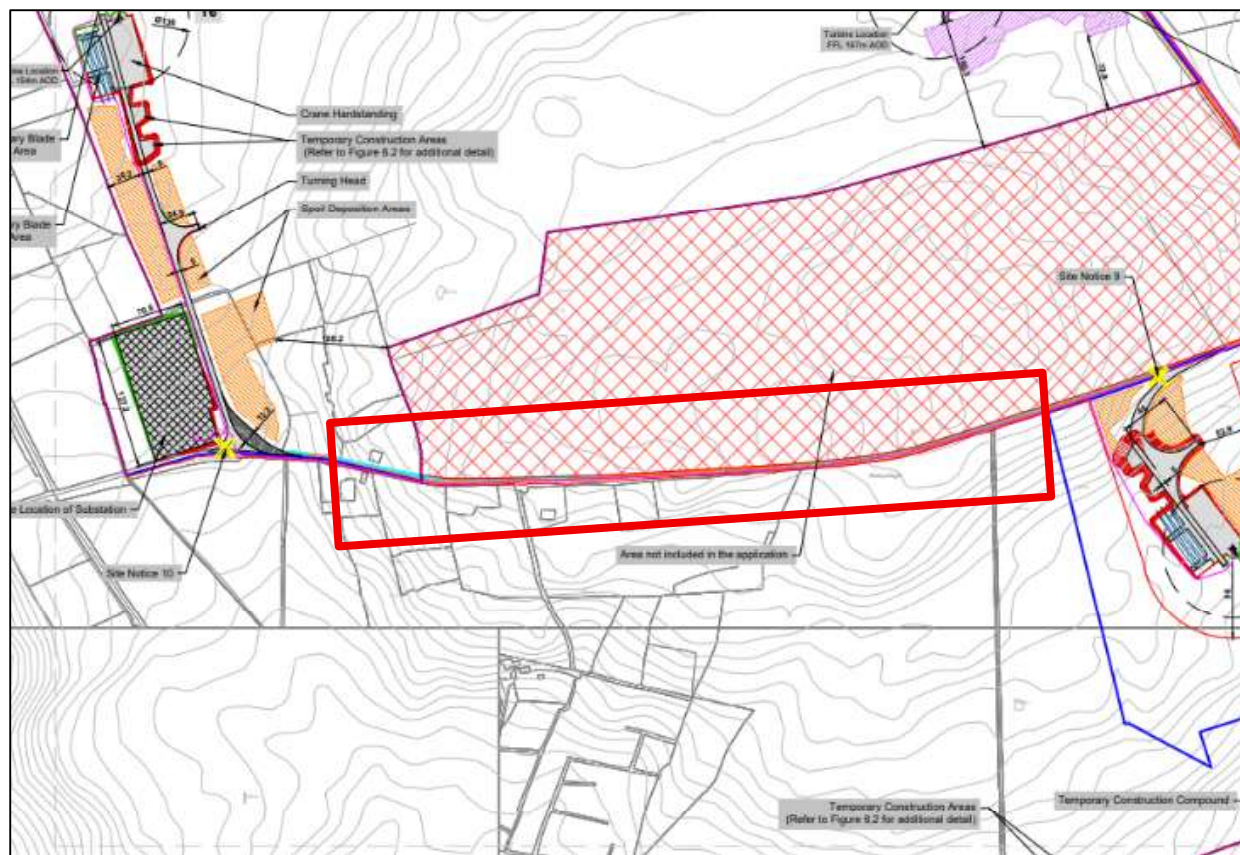
### Problem No. 03: Lack of Passing Opportunities

The audit team note from the site visit that there are limited opportunities for vehicles to safely pass along the narrow local roads. The audit team are concerned that the anticipated HGV and abnormal load traffic associated with the development may encounter opposing traffic along these sections. This may result in vehicles stopping, reversing or overrunning the roadside verge, increasing the potential for conflicts with other road users.

The design team should ensure that adequate provision for vehicles to safely pass and are appropriately sized for the anticipated delivery vehicles along the access route.

| Problem Reference in Safety Audit Report | To Be Completed by the Designer | | | To be Completed Audit Team Leader |
|---|---|---|---|---|
| P03 | Yes | Yes. Four dedicated passing bays have been proposed while vehicular traffic will also be able to make use of proposed site entrances and forestry entrances for passing opportunities. | | |

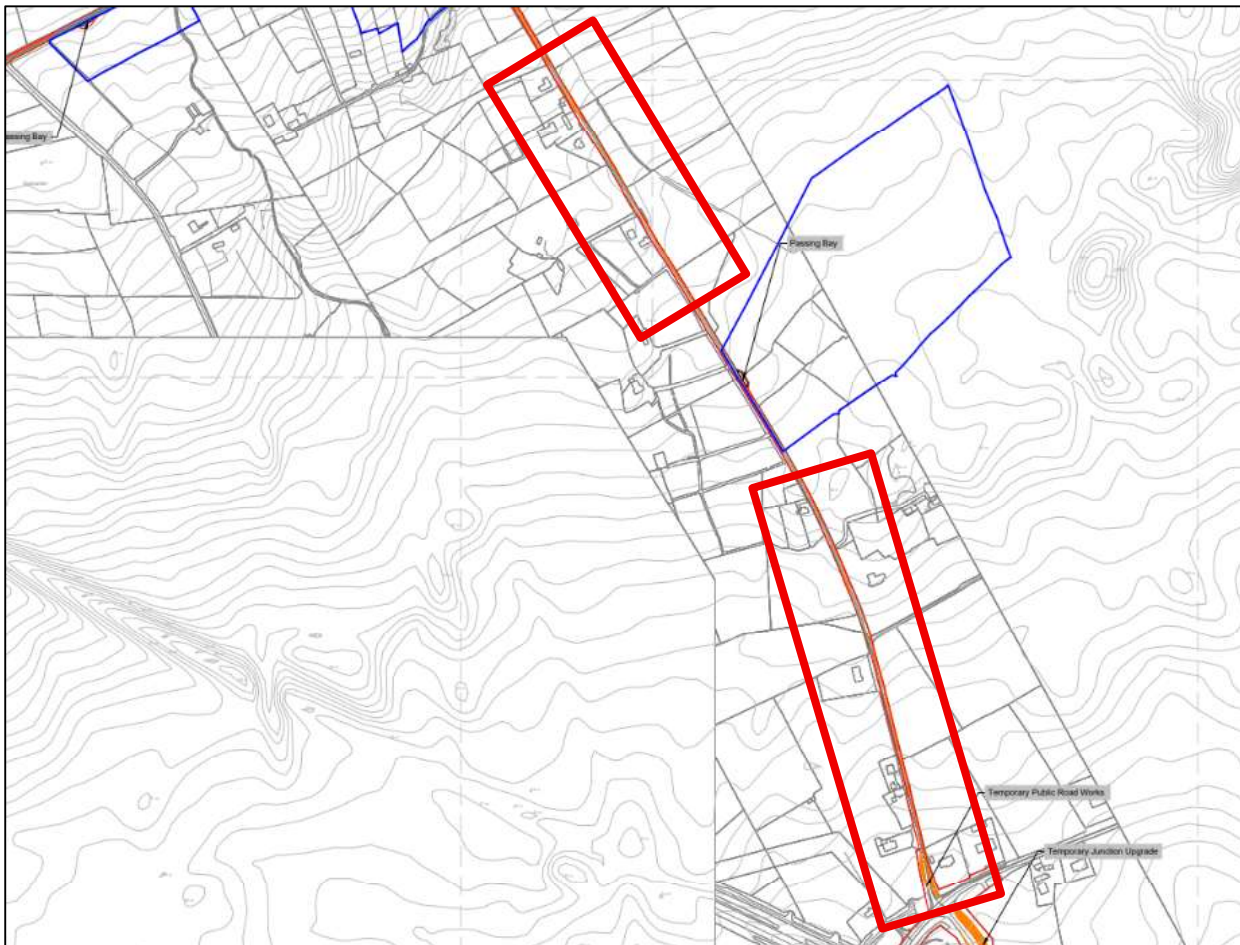
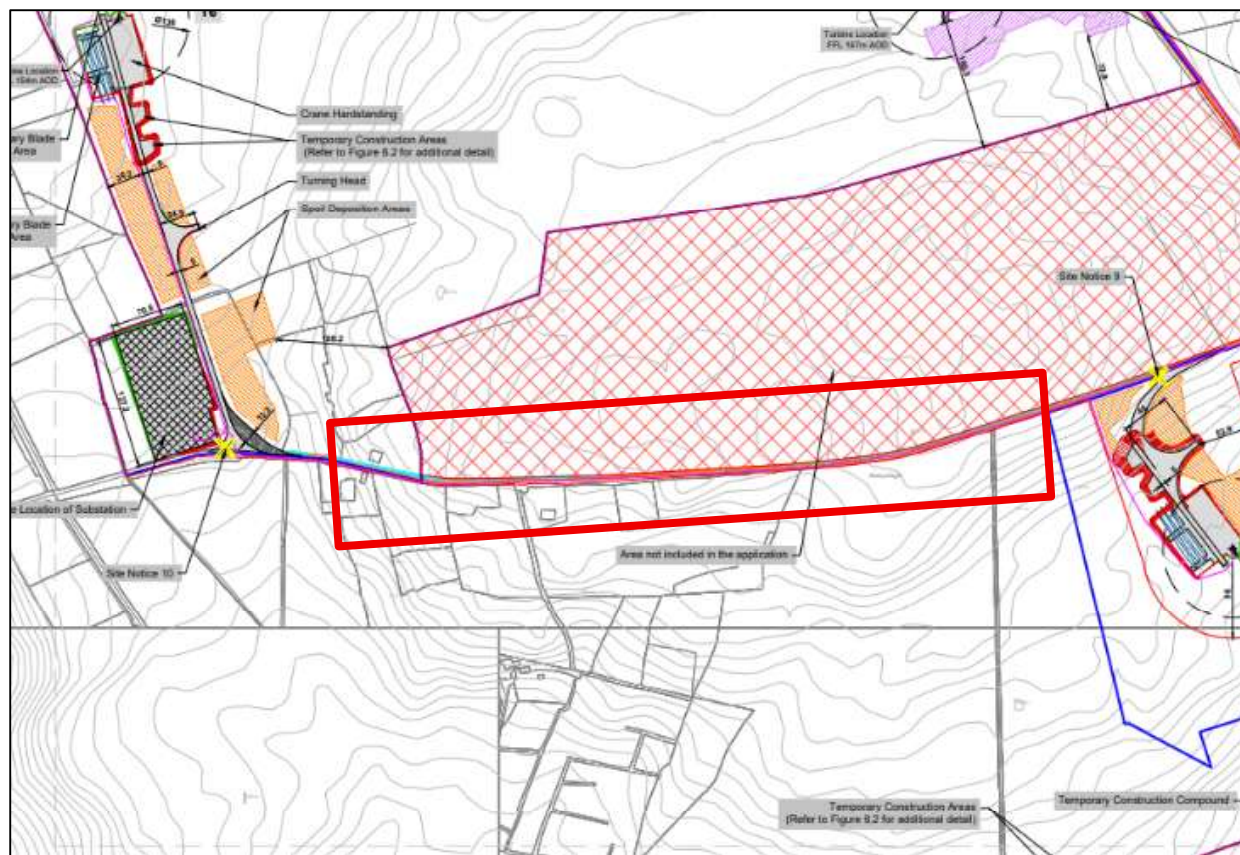
#### Problem No. 04: Intervisibility between Passing Areas

The audit team note from the drawings provided that it is intended to provide passing bays along the Local Road to ensure that large vehicles can safely pass one another due to the narrow nature of the existing road. However, it is unclear if appropriate intervisibility can be achieved from one passing bay to another to allow vehicles to safely stop in time to allow another vehicle to pass due to high ditches and vegetation along the Local Road.

The design team should ensure that clear visibility can be provided from one passing bay to another. The design team should also ensure that there is a dedicated Traffic Management Plan set out for the facility that provides dedicated delivery times for large vehicles to restrict the possibility of larger vehicles meeting along the Local Road.

| Problem Reference in Safety Audit Report | To Be Completed by the Designer | | | To be Completed Audit Team Leader |
|---|---|---|---|---|
| P04 | Yes | Yes. In addition to the dedicated passing bays, there are a number of other passing opportunities including at forestry and agricultural access points. A Traffic Management Plan will be prepared which will provide further detail on delivery schedules to minimise HGVs meeting along local roads. | | |

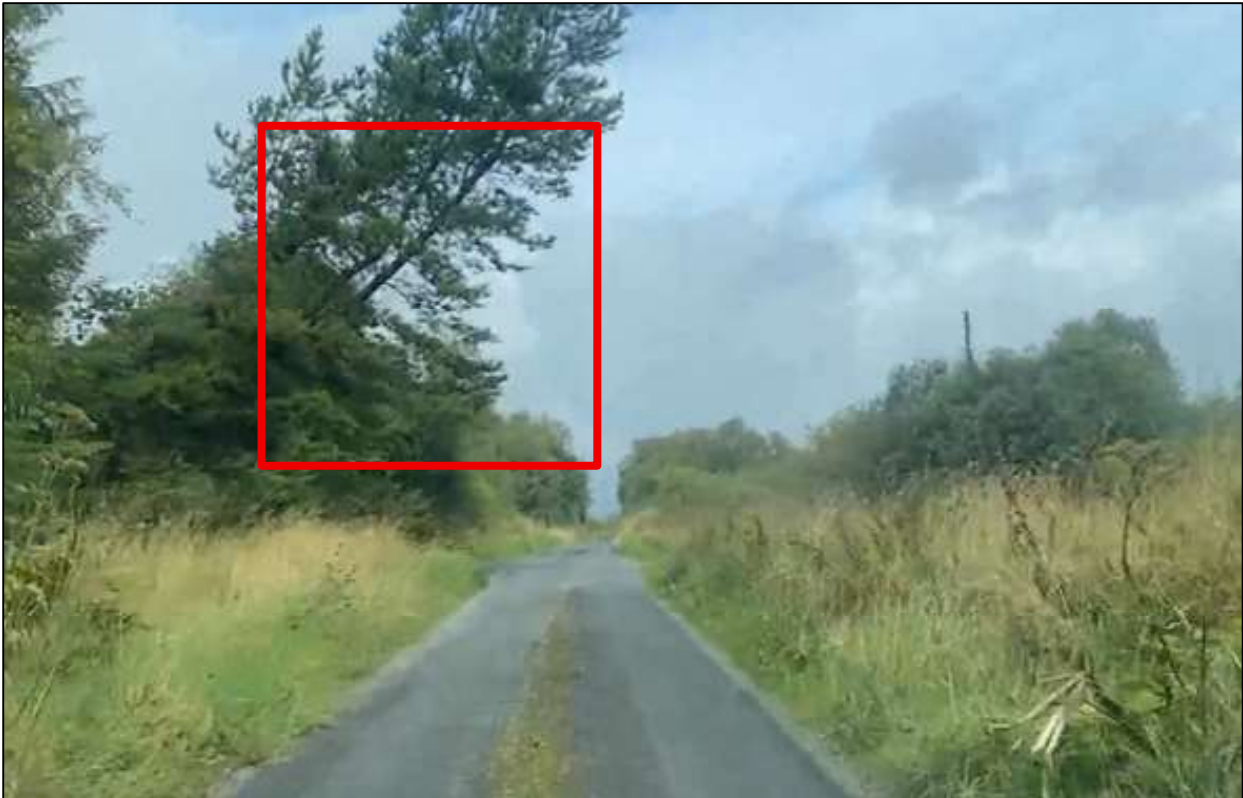
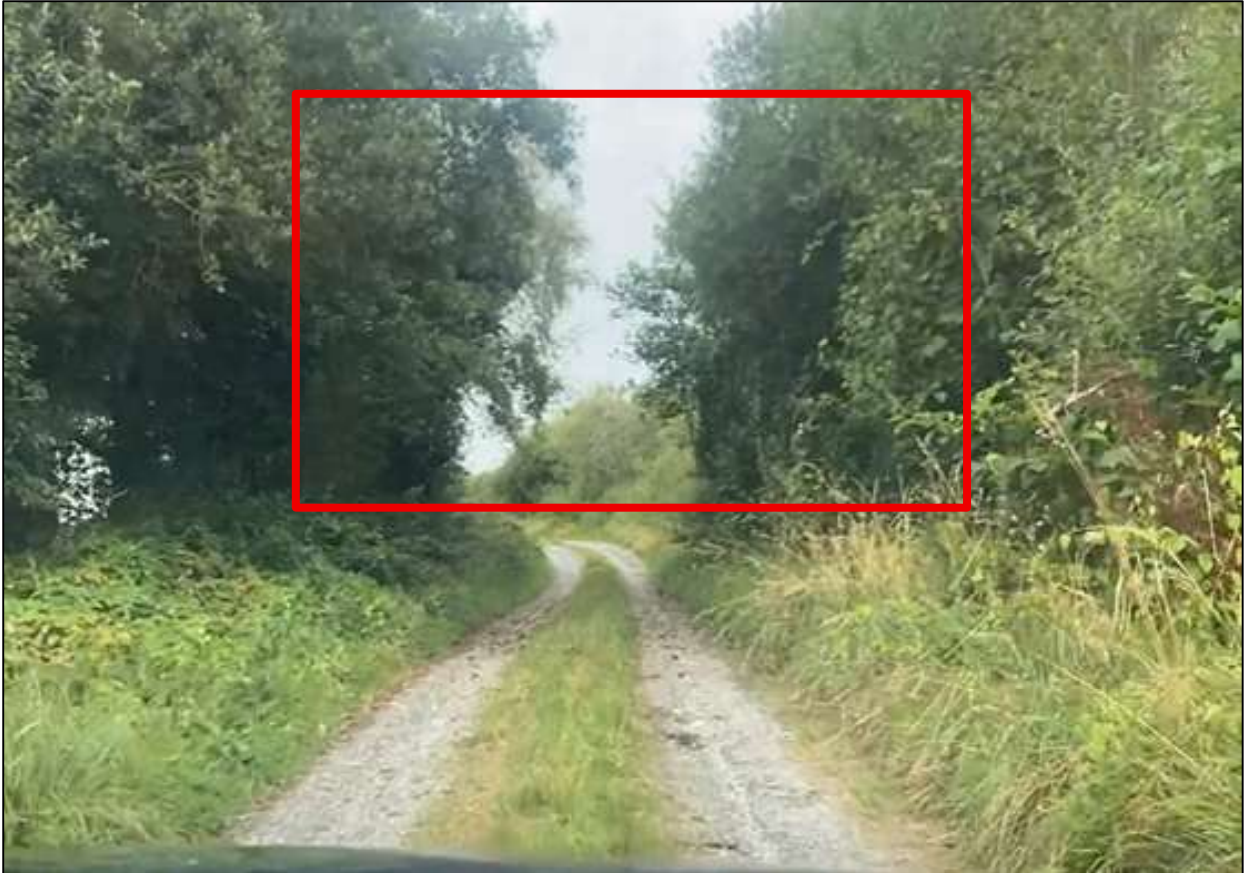
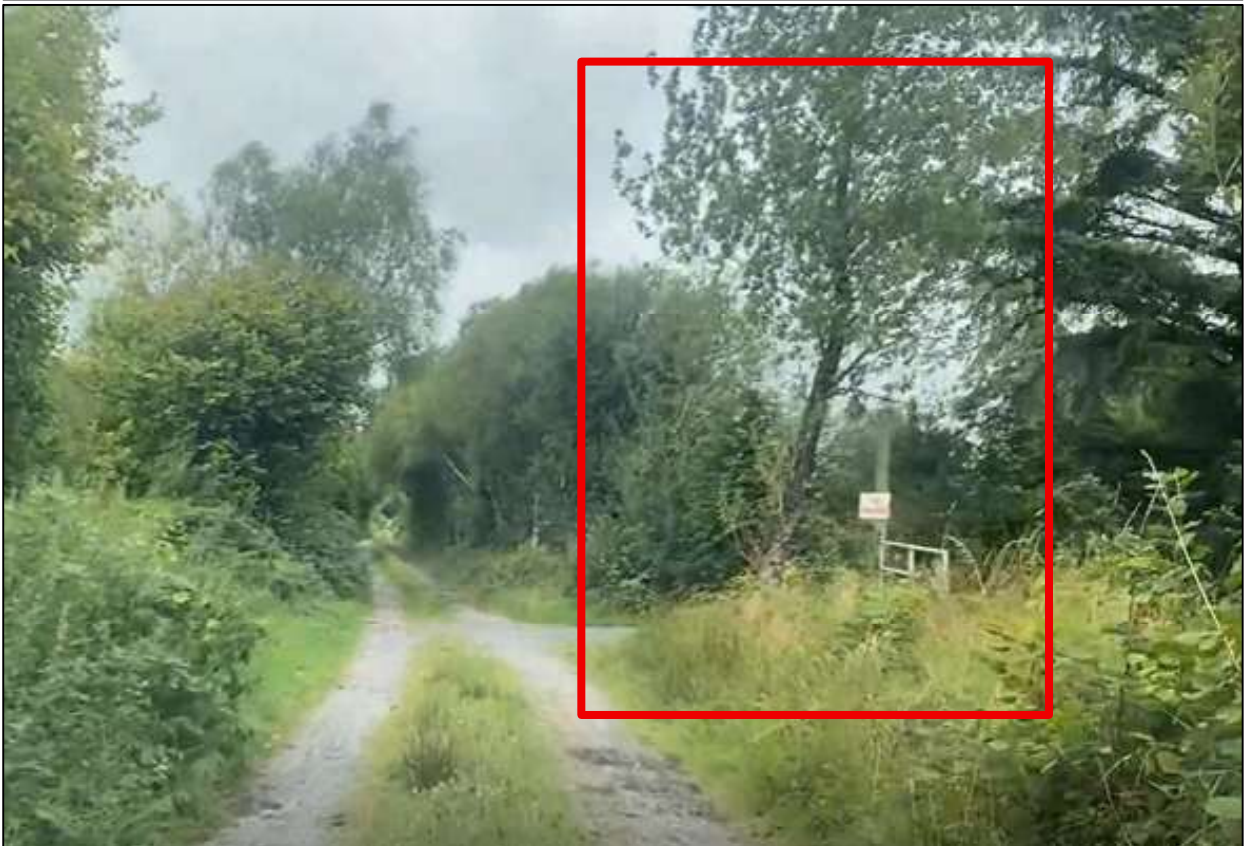
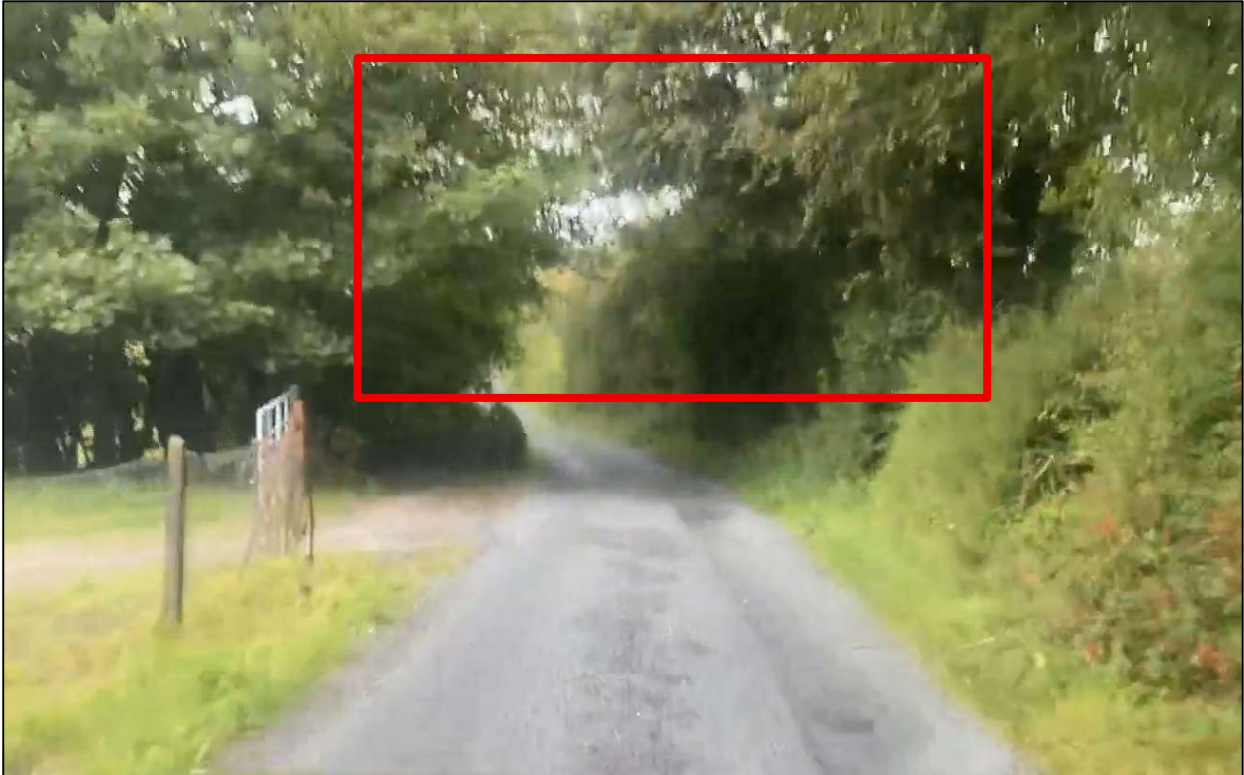
**Problem No. 05: Roadside Obstructions**

The audit team note from the site visit that existing roadside features including vegetation were located close to the carriageway. The audit team are concerned that these features may restrict the available road width for HGV and abnormal load movements and may be struck by vehicles travelling along the route.

The design team should ensure that existing roadside features do not present an obstruction or hazard to anticipated vehicle movements.

| Problem Reference in Safety Audit Report | To Be Completed by the Designer | | | To be Completed Audit Team Leader |
|---|---|---|---|---|
| P05 | Yes | Yes. Prior to the commencement of | | |

| | | construction, a number of haul route inspections will be carried out to ensure that all potential obstacles and hazards are removed. | | |

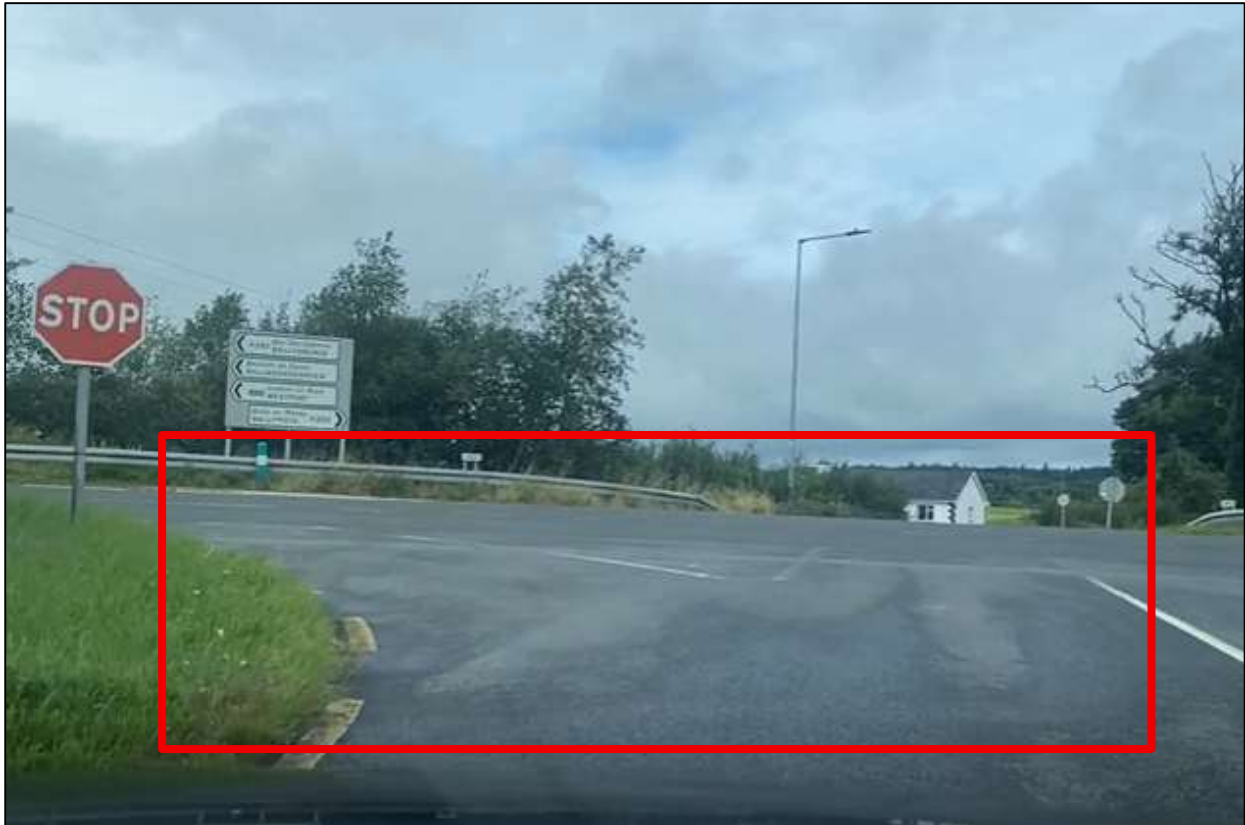
### **Problem No. 06: Absence of Stop Road Markings**

The audit team note from the site visit that the existing stop road markings at the junction identified appear worn and faded. Reduced visibility of the road markings may result in drivers having difficulty identifying the road layout and priority arrangements, increasing the potential for driver confusion and vehicle conflicts at the junction.

The design team should ensure that the existing stop road markings at the junction are reinstated and clearly visible to all road users.

| P06 | Yes | Yes. As part of the proposed development, the identified junction will be subject to upgrade works. As part of the reinstatement of these works, all road markings shall be reinstated and made clearly visible. | | |

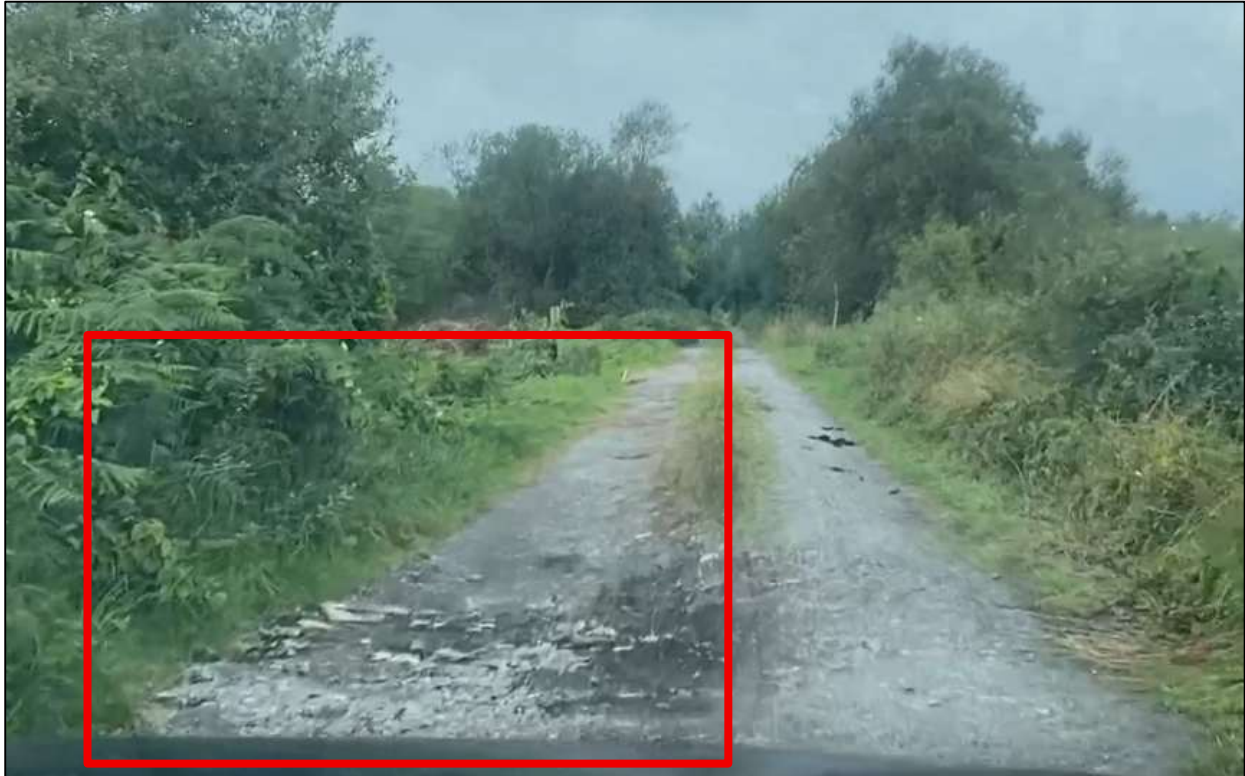
**Problem No. 07: Road Surface Condition****Location: Location Identified**

The audit team note from the site visit that the existing road surface appears to be in poor condition at the various locations along the route. The audit team are concerned that the increased HGV and abnormal load movements associated with the proposed development may accelerate deterioration of the existing road surface, potentially resulting in potholes, surface deformation and a reduced standard of road condition. This may increase the potential for loss of vehicle control and conflicts with other road users.

The design team should ensure that the existing road is of a suitable standard to accommodate the anticipated HGV and abnormal load movements associated with the proposed development. These photos are examples and checks should not be confined to these areas only.

| P07 | Yes | Yes. The proposed development provides for the upgrading of the carriageways, as required, of local roads in the vicinity of the site prior to the commencement of construction. Similarly, post-construction, where any deterioration is identified and is directly attributable to the construction works, remedial measures/actions shall be undertaken. | | |

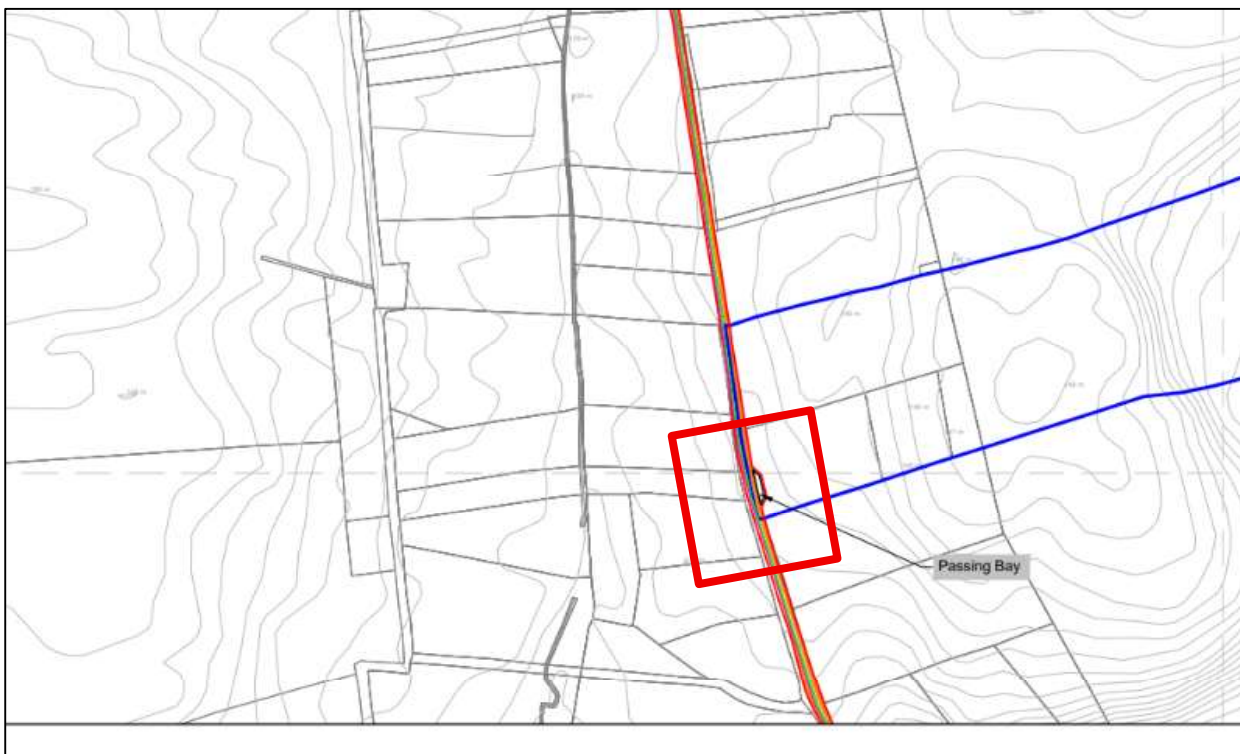
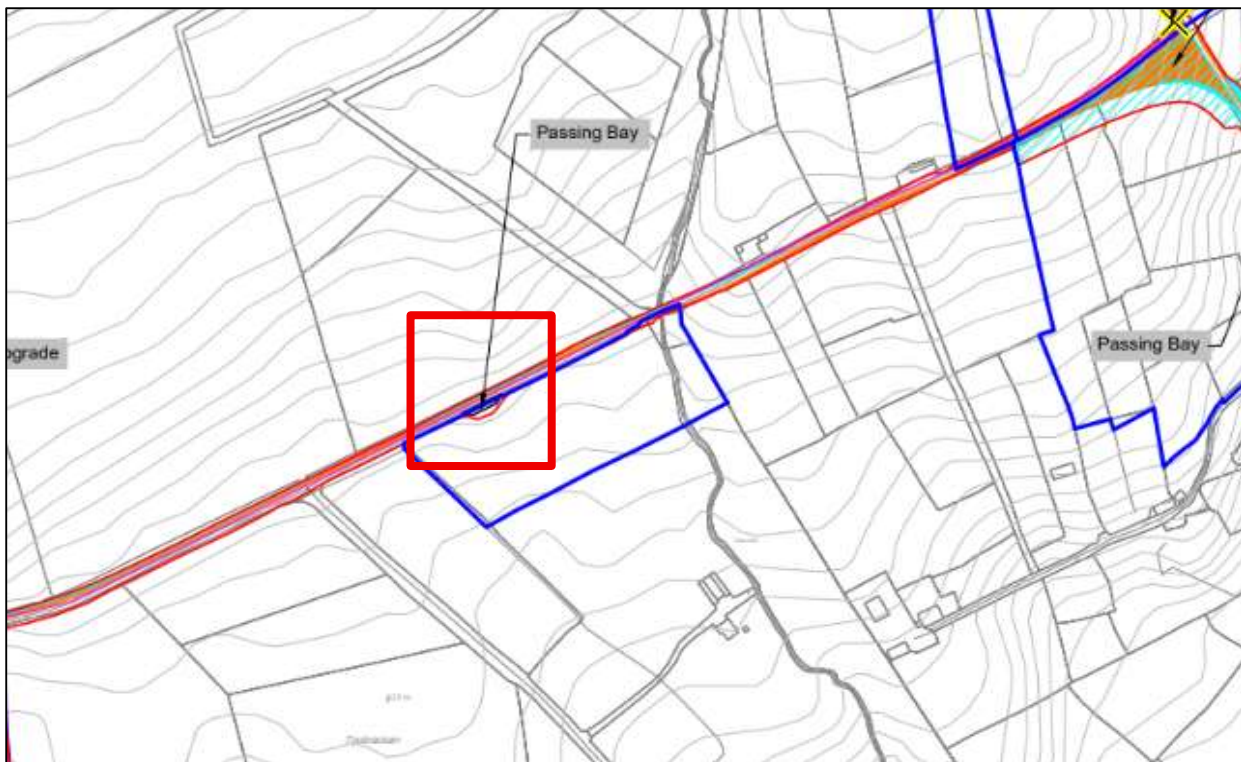
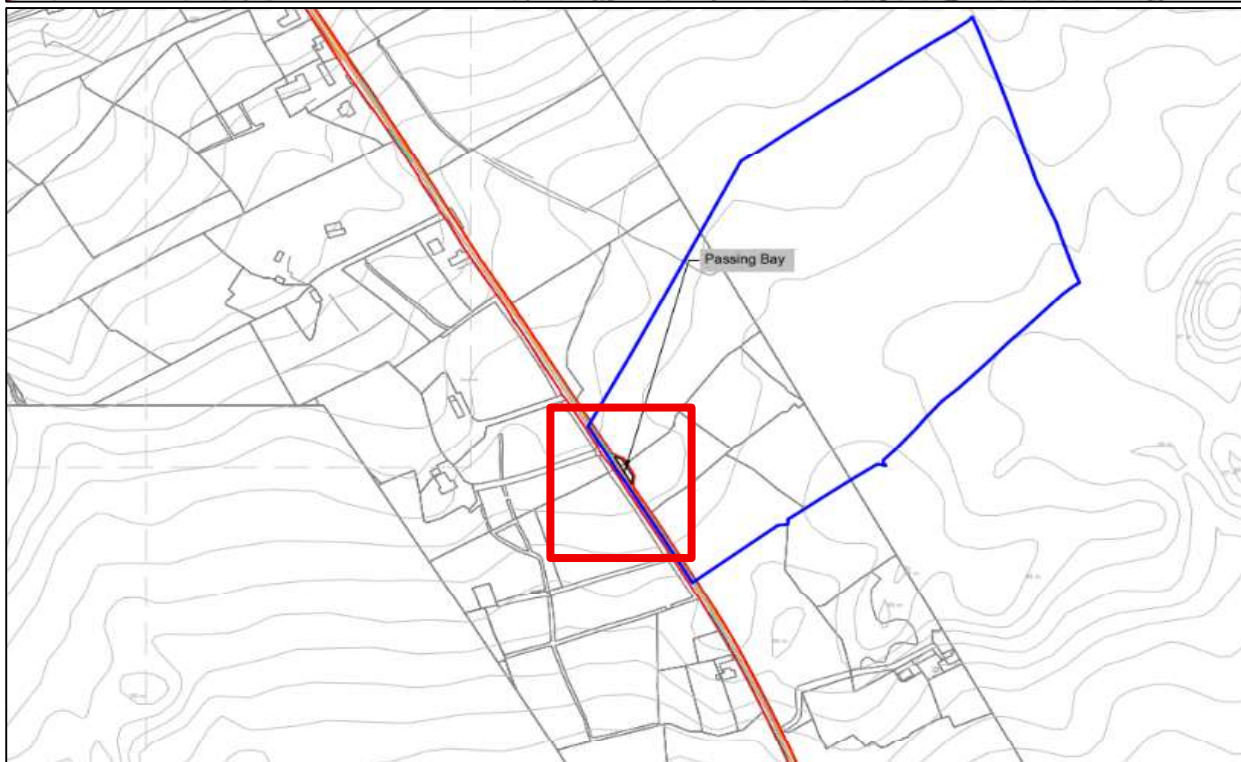
### Problem No. 08: Lack of Drainage Provision at Passing Bays

The audit team note from the drawings provided that there is limited information regarding drainage provision at the proposed passing bays and road widening locations. The audit team are concerned that the proposed widening may alter existing overland flow paths and that inadequate drainage provision may result in surface water ponding on the carriageway and passing bays. This may result in reduced skid resistance and vehicle control issues, particularly during periods of heavy rainfall.

The design team should ensure that appropriate drainage measures are provided at the proposed passing bays and road widening locations to maintain existing drainage paths and prevent surface water ponding on the carriageway.

| P08 | Yes | Yes. As part of the post-consent detailed design process, appropriate drainage infrastructure shall be incorporated into the passing bay design. | | |
