## **Islandmore Wind Farm**

Annex 14.1: Road Safety Audit

**Wind Farm Application, Toobrackan,  
Ballaghaderreen, Co. Roscommon  
Stage 1 Road Safety Audit**

| <b>Document No:</b> | 262305-ORS-XX-XX-RP-TR-13g-001 - RSA |

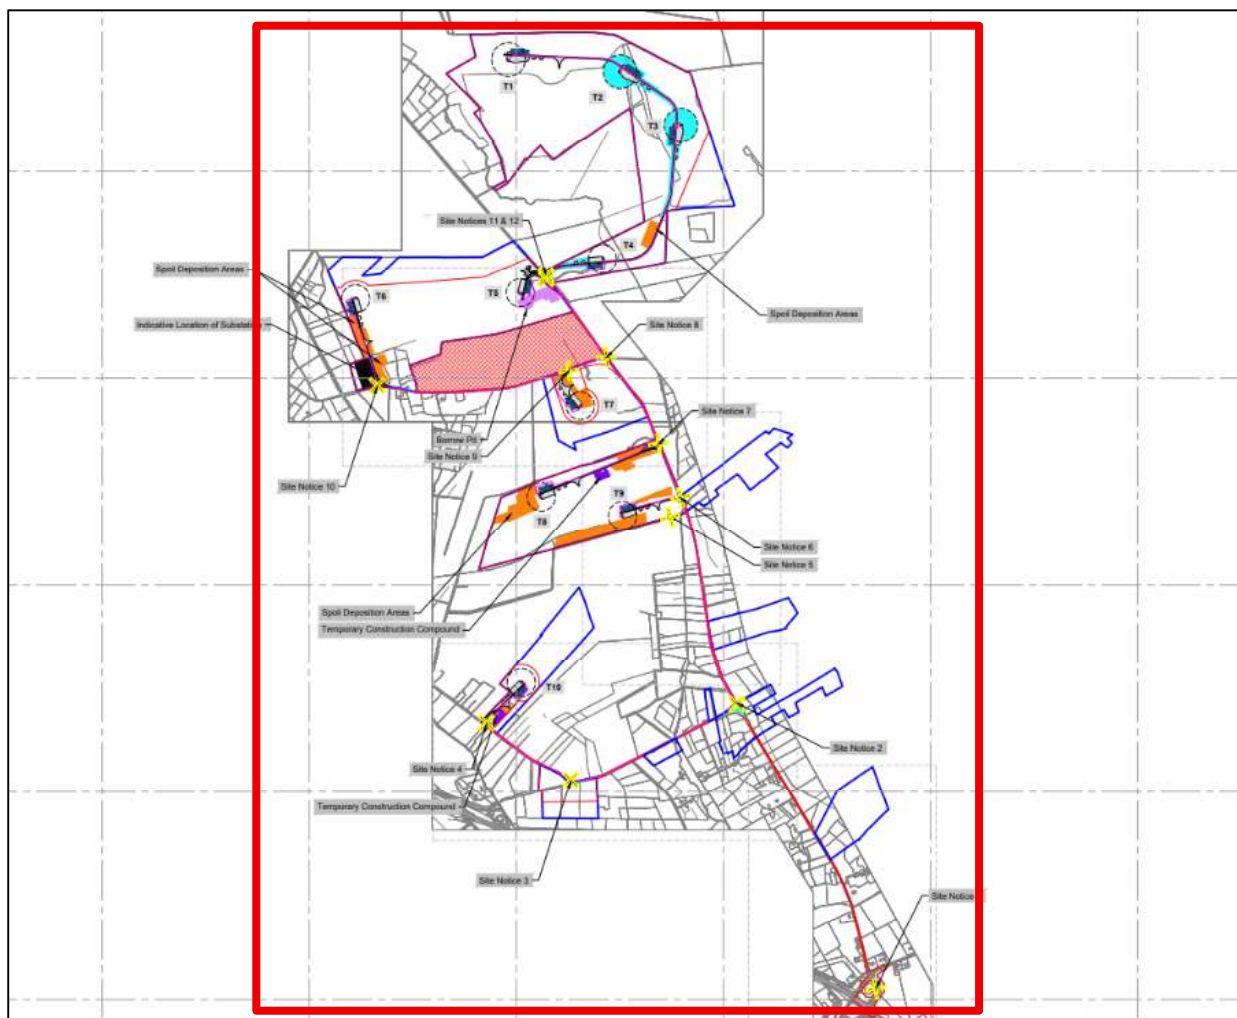
### Problem No. 09: Absence of Nacelle and Turbine Blade Swept Path Analysis

The audit team note from the drawings provided that no swept path analysis has been provided to demonstrate that the proposed turbine delivery vehicles can safely negotiate the identified locations along the delivery route. The audit team are concerned that the proposed turbine blades will extend beyond the trailer during transportation and that the associated blade oversail has not been demonstrated. This may result in the blade and/or delivery vehicle conflicting with existing roadside features, vegetation, drainage infrastructure, boundaries or other obstructions, potentially requiring additional road widening or clearance works.

The design team should ensure that a detailed swept path analysis is undertaken for the proposed turbine delivery components and the associated vehicles, including the nacelle full blade configuration and anticipated nacelle and blade oversail, to identify any locations requiring additional road/junction widening, passing bay provision, clearance or other mitigation measures.

| P09 | No. | Yes. A detailed Route Access Survey has been conducted and the necessary works required to enable the delivery of turbine components to the project site are known and have been incorporated into the proposed development as required. | | |

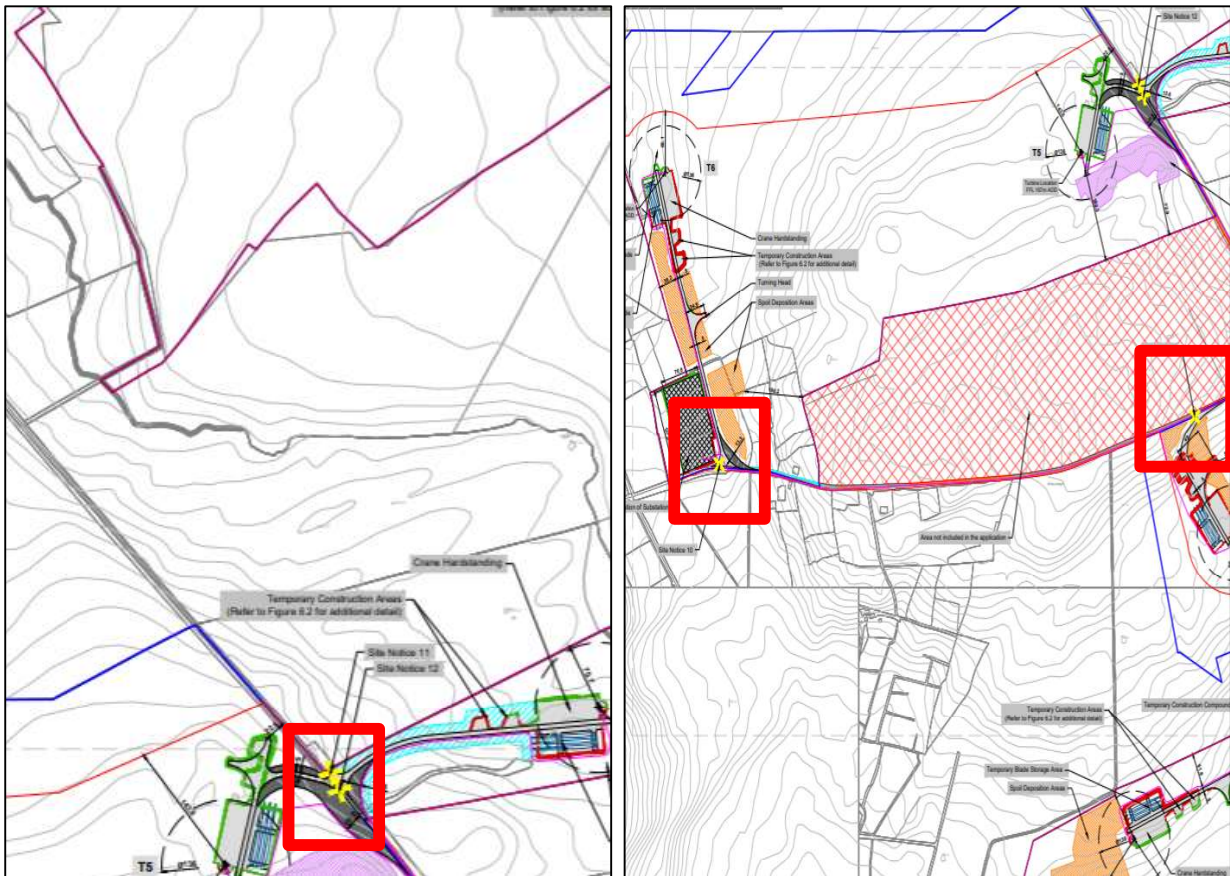
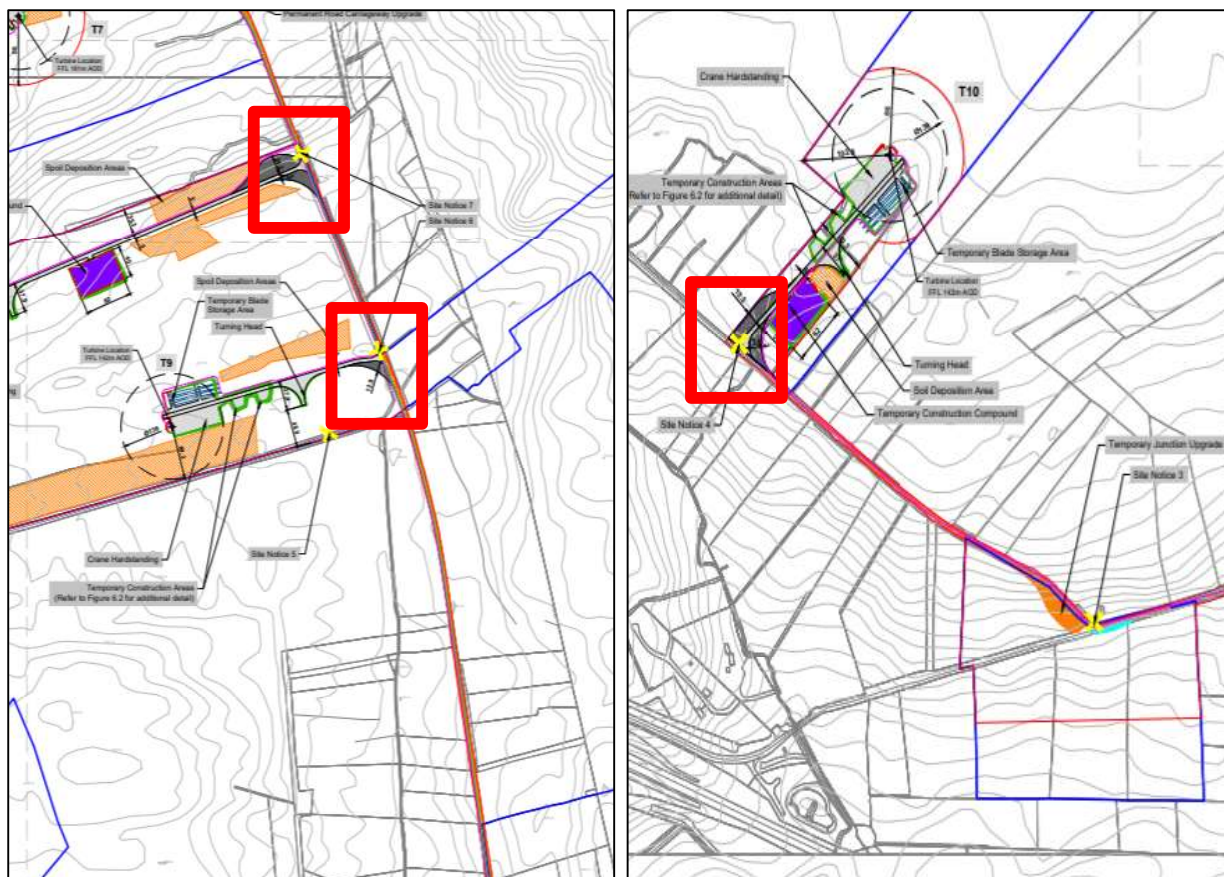
## Problem No. 10: Risk of HGV Queuing on Local Road to Closed Site Access Gate

The audit team notes from the design drawings that there is a lack of clarity regarding vehicle queuing on the Local Road when the site access gate is closed. This presents a potential road safety risk, particularly for Heavy Goods Vehicles (HGVs) waiting to enter the site. Stationary vehicles on the live carriageway can obstruct traffic flow, reduce available sight distance, and create collision hazards for approaching vehicles — especially during low visibility conditions such as at night or in adverse weather. This situation increases the likelihood of rear-end or side-swipe incidents.

The design team should ensure that the site access is located to provide an appropriate off carriageway holding space for vehicles waiting to enter the site.

| P10 | Yes | Yes. As part of the post-consent detailed design process, the precise siting of boundary fencing and gates shall be defined. However, the design process shall ensure that gates are adequately set back from the road edge to allow a HGV pull fully off the road and to avoid queuing on the public road. | | |
